Associated Press
Printer
Interface
(APPI)
Installation Manual

This simple guide is intended to help you in the installation of the hardware used for receiving the APTN script service.

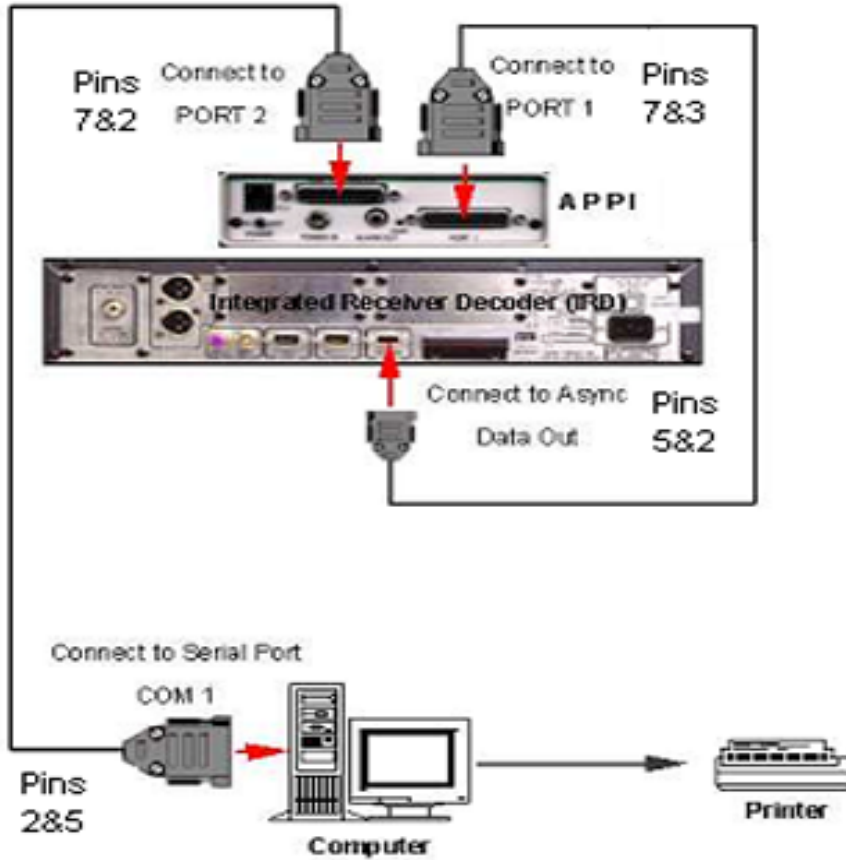
Correct way of connecting equipment

APPI = Associated Press Printer Interface

APTN utilizes the NAA/ANPA and IPTC format structure to deliver scripts to the International Broadcast Industry. Data is delivered at 9600bps via a smart interface device called an APPI. This device converts the AP wire feed to the various formats, codes and speeds. Delivery is available at 9600bps (**default**), 4800bps, 2400bps, and 1200bps. **9600bps is recommended.** Data is transmitted with 1 start bit, 8 data bits, no parity, and 1 stop bit. The NAA/ANPA and IPTC format structure is selectable.

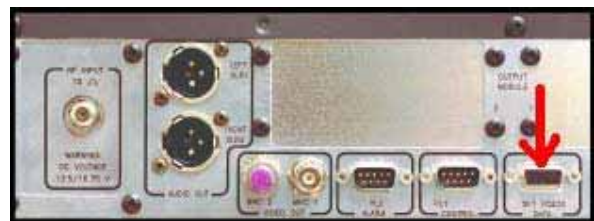
RS232 – Data Port, at pins 2 & 5

- Pin 2 ---> (Signal)
- Pin 5 ---> (Ground)
- Normal Voltage = -9 Volts DC
